# Westbury Platform 0

Recommissioning & Consequential Works ES2 Report

January 2026

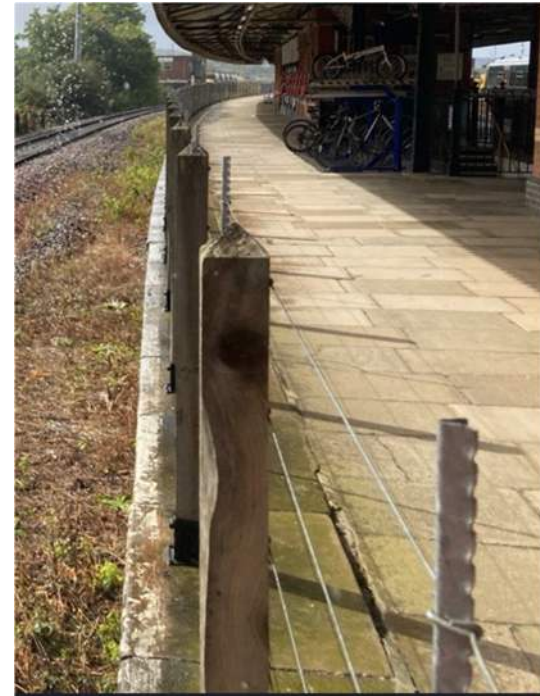
- Non-operational since 1984
- Uneven surfacing, cracked paving slabs
- Widespread uneven “crossfall” sloping towards track, risk to wheeled vehicles and users
- Crossfall non-compliant with RIS-7016-INS standards (ideally 1:50, nominally 1:40 to 1:80 away)
- Coper edge needs be ideally 915mm above rail edge (without crossfall being too steep)
- Platform edge, crossfall, vertical alignment, building & stairwell thresholds and S&C at the platform ends need to be compatible
- 118-metre platform 0/1 canopy covers 50% of platform and is longer than platform 2/3 canopy

- Resurface entirely & level to reduce trip hazards
- Crossfall ideally 1:50 (from 1:40 to 1:80)
- Install tactile paving
- Ensure platform furniture does not create pinch points

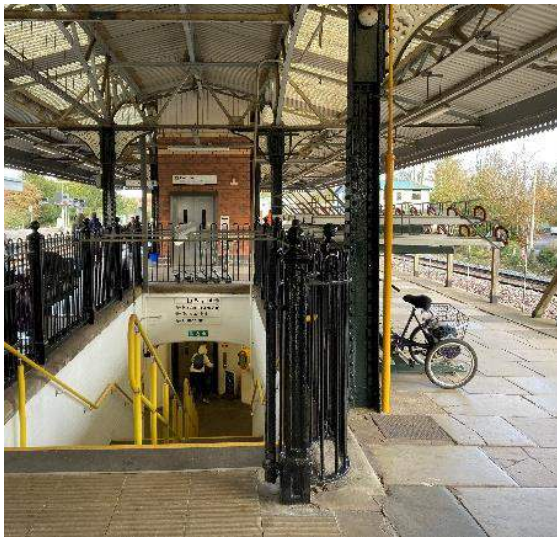
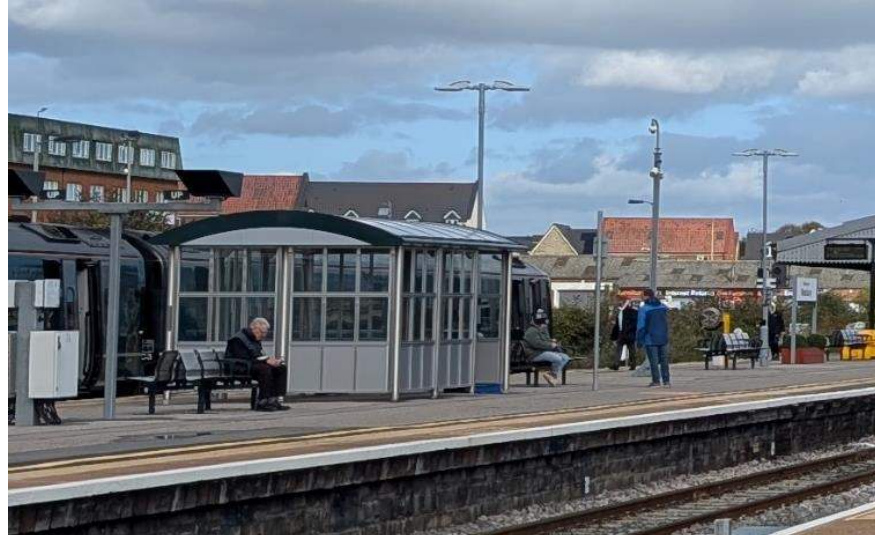
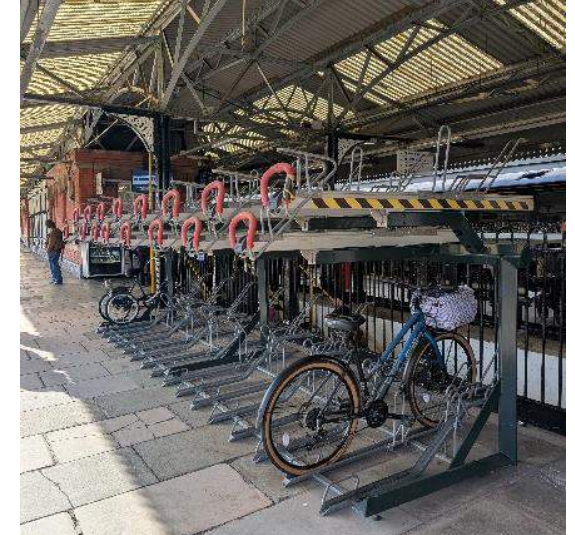
32 cycle spaces on disused platform 0, relocate to avoid obstruction.

Located near lift & stairs on each island platform.

Passenger increase may create pinch-point.

Consider relocation on each island platform.

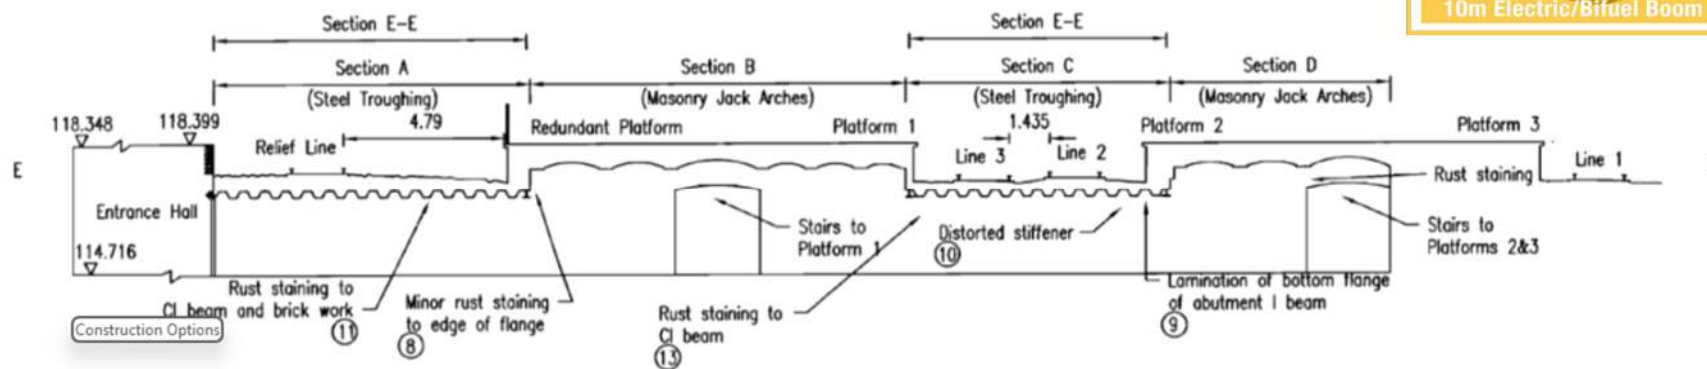
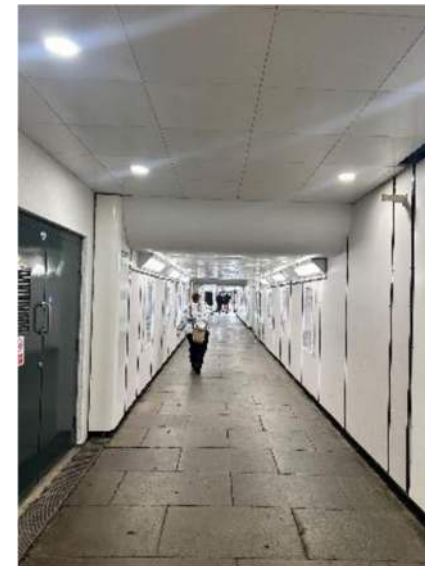
- Only public access between entrance hall & platforms
- Track formations carried by trough decks
- Platforms supported by concrete jack arches & cast-iron girders
- Previous condition assessments = fair to good
- Corrosion at beam/abutment interface
- Cast iron beams adequate for pedestrian & maintenance vehicle live loading for all platforms
- Jack arches for platform 2/3 adequate for pedestrian & maintenance vehicle live loading combined (full-depth concrete to up to paving slabs).
- Jack arch for platform 1 inadequate for pedestrian live loading or maintenance vehicle live loading (Halouette Star 10) (lesser-depth concrete with loose-fill above to paving slabs)
- Track-bearing trough in satisfactory condition (Sept 2002 assessment), safer than RA10 at 40mph (one track or two?)
- Ballast depth 60mm above trough deck, but may vary following Down Reception line works in 2025.

- Undertake level 1 assessment for structure (includes cladding removal) & possible further assessments (discussed with W&W assessment team)
- Ascertain fill depths (including ballast),
- Platform 0 trial hole to establish fill material and possible next steps
