# Westbury Platform 0

Recommissioning & Consequential Works ES2 Report

January 2026

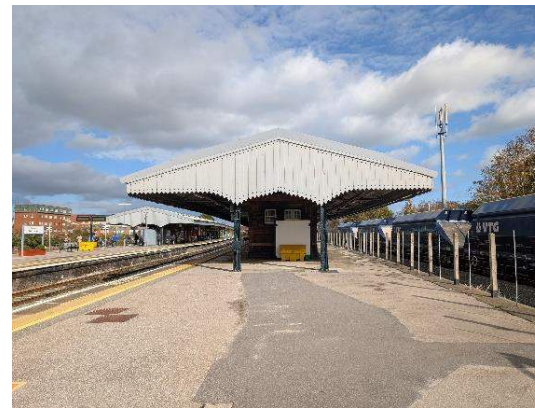
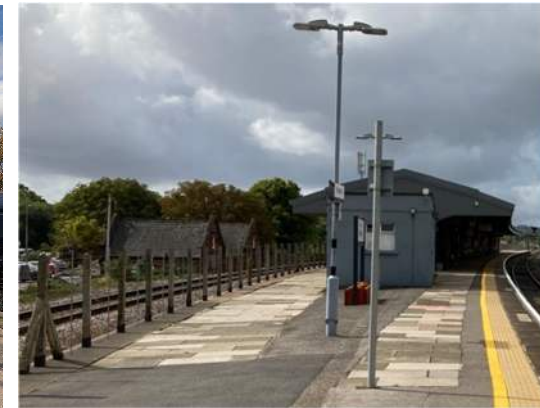
Kiosk selling hot & cold drinks & light refreshments within platform 2/3 waiting room. High demand at time of visit.

Vending machine on platform 1 at top of stairs, below train departure screen

Waiting room on platform 1 with 12 seats & heating, demand likely to increase with platform 0.

Benches & external shelter on 2/3, emulate on 0/1 to encourage even passenger distribution in trains

No catering change recommended, but platform 0/1 buildings could be converted, subject to additional budget.
